Leakage Troubleshooting Guide

I. SEAL LEAKAGE TROUBLESHOOTING GUIDE

Causes of Seal Leaks

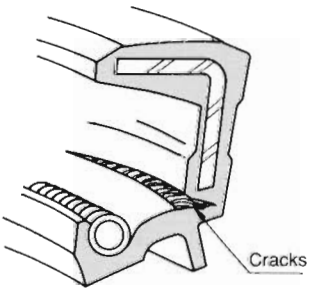
| Factor | | Failure mode | Cause | Solution |
|--|---|---|---|---|
| Broken waist (flex section) of the lip | Improper assembly | There are cracks on the hinge flex area of the lip. | <ul style="list-style-type: none"> ●The lip hinge flex section cracked because the lip was squeezed out of shape during assembly. | <ul style="list-style-type: none"> ●Assemble the unit carefully by aligning the shaft and housing bore. |
| | High internal pressure | | <ul style="list-style-type: none"> ●The lip hinge flex section cracked due to excessive pressure during a post-assembly pressure test (air-leak test). | <ul style="list-style-type: none"> ●Avoid testing at a pressures higher than the design limits of the seal. |
